**Region 9 Enforcement Division
75 Hawthorne Street
San Francisco, CA 94105**

SECTION I – INTRODUCTION

I.1 Purpose of the Virtual Inspection

The purpose of the virtual inspection was to evaluate the operation of Hilmar Cheese Company's (Hilmar, Facility) Class I injection wells for compliance with the U.S. Environmental Protection Agency's (EPA) Safe Drinking Water Act (SDWA) and the Facility's Underground Injection Control (UIC) permit No. CA10500001 (Permit). This virtual inspection was conducted via a Microsoft Teams video conference call.

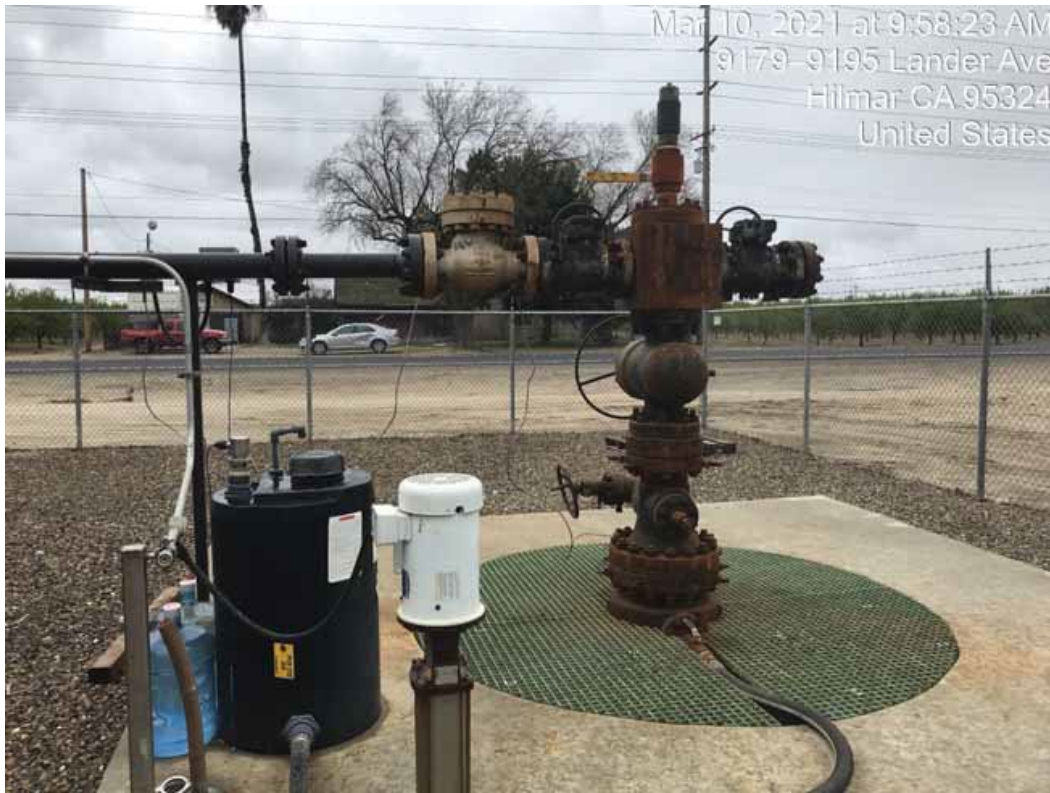
PHOTO 4 – WD-2 Annular Pressure Gauge

- PHOTO 3 shows an annular pressure data system readout of 10PSI at well WD-2 on March 10, 2021 at 10:03AM.
- PHOTO 4 shows an annular pressure gauge reading of 10.0PSI at well WD-2 on March 10, 2021 at 10:07AM.

a) Item C.8.b of the Permit requires that 100PSI be maintained on the tubing and annulus during shut in conditions. Well WD-2 has been shut in since March 2012. The injection pressure reading observed during the virtual inspection was 0PSI and the annular pressure was 12PSI. PHOTO 4 shows an annular pressure reading of 10.0PSI. Failure to maintain 100PSI on the tubing and annulus during shut in conditions constitutes a potential violation of the Permit.
